Structure of welded joints of 14MoV6-3 and 13CrMo4-5 steel elements after design work time under creep conditions

A. Zieliński*, J. Dobrzański, M. Dziuba-Kaluża

Institute for Ferrous Metallurgy, ul. K. Miarki 12, 44-100 Gliwice, Poland

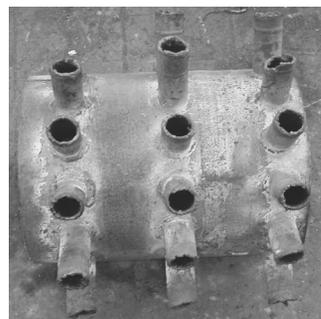
Fig. 2. Material for investigations in the form of 13CrMo4-5 (15HM) steel homogeneous circumferential welded joint of II° secondary steam superheater header shell after 140,000 h service

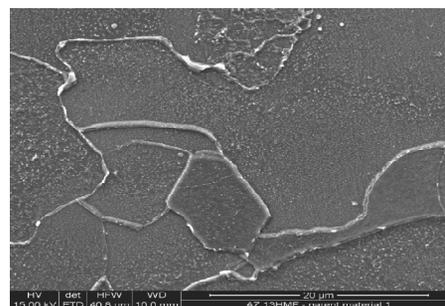
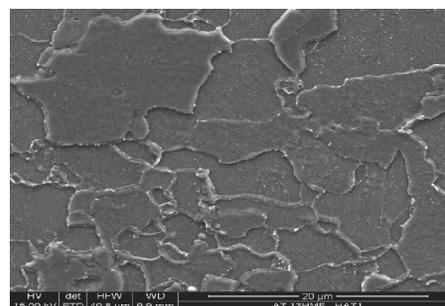
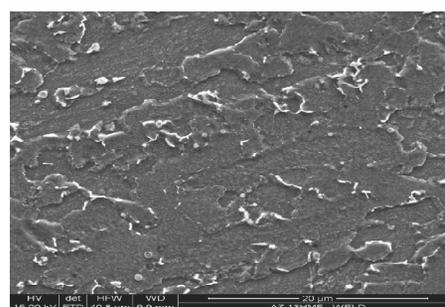
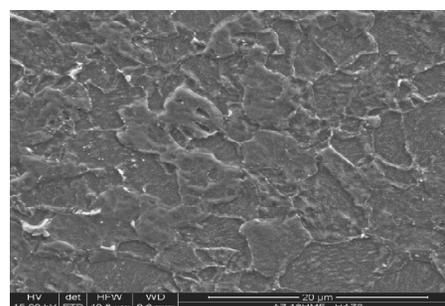
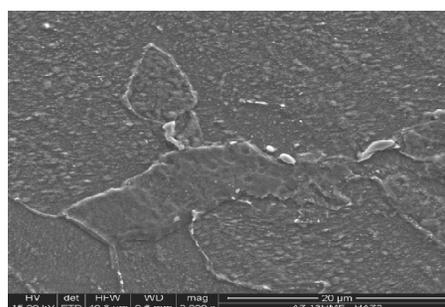
Fig. 8. Material structure of 14MoV6-3 steel welded joint after 200.000 h service. Investigation area marked as ZGP1/R

Within the examined structure of the materials of elements of 14MoV6-3 steel primary steam pipeline circumferential welded joint and 13CrMo4-5 steel II° secondary steam superheater header after service under creep conditions, neither discontinuities and micro-cracks nor initiation of processes of internal damages as a result of creeping were observed.

Review of the results of investigations on microstructure of material of 14MoV6-3 steel welded joint

Area of investigation/ HV10	Description of microstructure Material condition – life exhaustion extent	HV10
Parent material 1	Ferritic-bainitic structure. Bainitic areas partially coagulated. At ferrite grain boundaries, few fine precipitations of different size. Precipitations inside ferrite grains, mostly very fine, distributed evenly within the structure. No discontinuities and micro-cracks observed in the structure.	159
Parent material 2	Bainitic areas: class I, precipitations: class a <u>Destruction processes: class O</u> CLASS 1/2, LIFE EXHAUSTION EXTENT: approx. 0.3	153
HAZ 1	Heat-affected zone structure. No discontinuities and micro-cracks found in the structure.	167
WELD	Structure of welded joint weld material. No discontinuities and micro-cracks found in the structure.	218
HAZ 2	Heat-affected zone structure. No discontinuities and micro-cracks found in the structure.	172

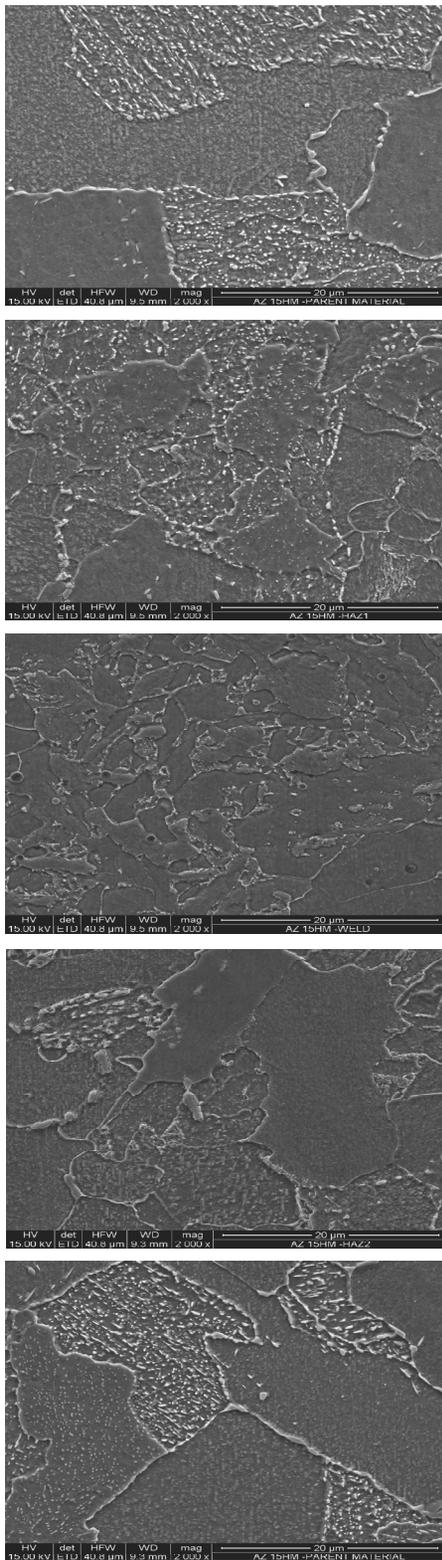
Fig. 9. Material structure of 13CrMo4-5 steel welded joint after 140,000 h service. Investigation area marked as ZGP1/R

Review of the results of investigations on microstructure of material of 13CrMo4-5 steel welded joint

Area of investigation/ HV10	Description of microstructure Material condition – life exhaustion extent	HV10
Parent material 1	Ferritic-pearlitic-bainitic structure. pearlite/bainite areas partially coagulated. At ferrite grain boundaries, numerous precipitations forming chains in places. inside ferrite grains, single fine precipitations.	155
Parent material 2	Pearlite/bainite areas: class I, precipitations: class a <u>Destruction processes: class O</u> CLASS 1/2, LIFE EXHAUSTION EXTENT: approx. 0.3	157
HAZ 1	Heat-affected zone structure. No discontinuities and micro-cracks found in the structure.	166
WELD	Structure of welded joint weld material. No discontinuities and micro-cracks found in the structure.	197
HAZ 2	Heat-affected zone structure. No discontinuities and micro-cracks found in the structure.	197

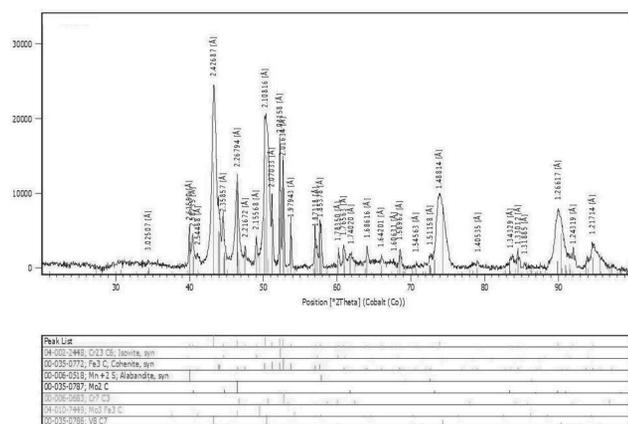
Fig. 12. Phase composition diffractogram for carbides in material of the 14MoV6-3 steel pipeline after long-term service under creep conditions

Material condition	Phase composition of carbides
Initial state	M ₃ C + MC
Service 200,000 h	V ₈ C ₇ - main phase
	Fe ₃ C - very much
	Mn ₂ S - medium
	Mo ₂ C - medium
	Cr ₂₃ C ₆ Isowit - little
	Cr ₇ C ₃ - few
	Mo ₃ Fe ₃ C - trace

The X-ray diffraction analysis of the deposit of carbides isolated electrolytically from the matrix of material of the examined test piece of the primary steam pipeline confirms the existence of significant amount of carbides, which are usually present in initial state as M₃C, and additionally M₈C₇ carbide as the main phase and slight amounts of M₂C, M₂₃C₆, M₇C₃ and Mo₃Fe₃C carbides and Mn₂S compound, as the result of simultaneous impact of high temperature and time due to service.

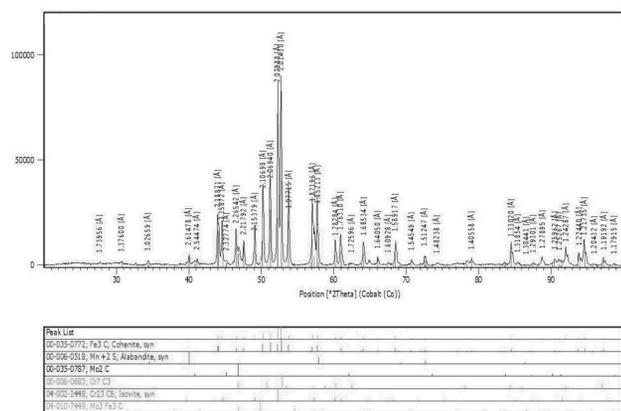
Fig. 13. Phase composition diffractogram for carbides in material of the 13CrMo4-5 steel II° secondary steam superheater header after long-term service under creep conditions.

Material condition	Phase composition of carbides
Initial state	M ₃ C+(M ₂ C)
Service 140.000 h	Fe ₃ C - main phase
	Cr ₂₃ C ₆ Isowit - much
	Mo ₂ C - little
	Mn ₂ S - little
	Cr ₇ C ₃ - trace
	Mo ₃ Fe ₃ C - trace

Whereas in case of analysis of the deposit of carbides isolated electrolytically from the matrix of examined material of the II° secondary steam superheater, the X-ray phase analysis confirmed the existence, in addition to M₃C (main phase) and M₂C carbides in initial state, of M₂₃C₆ carbides in large amount as well as M₇C₃ and Mo₃Fe₃C carbides (with slight content) and Mn₂S compounds as a result long-term service.
