The evaluation of suitability for operation of low-alloy Cr-Mo and Cr-Mo-V steel welded joints beyond the design work time

Purpose: The purpose of this paper was to develop material characteristics for homogeneous circumferential welded joints in low-alloy steel steam pipelines of power units after long-term service beyond the design work time.

Fig. 1. Material for investigations in the form of homogeneous circumferential welded joint after 240 000 h service under creep conditions: a) primary steam pipeline from 14MoV63 steel (marked 1); b) secondary steam pipeline 10CrMo9-10 (marked 2)

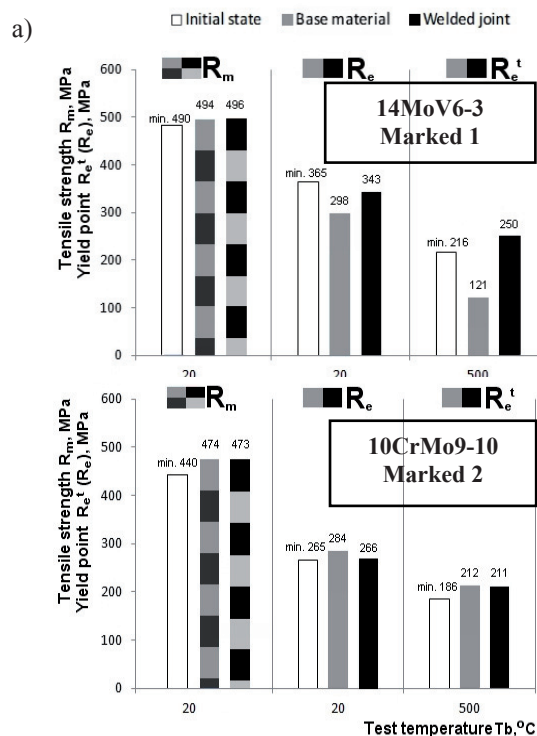
Fig. 2. Results of mechanical testing of the material of tested specimens with homogeneous circumferential welded joint after 240 000 h service under creep conditions: a) tensile strength and yield point at room and elevated temperature

For the 14MoV6-3 steel primary steam pipeline after 240 000 h service, the requirements for yield point at room temperature for both the parent material and welded joint and the requirements with regard to yield point at a temperature similar to the operating one for the parent material are not met. Also, the brittle fracture appearance transition temperature for the parent material of the tested 14MoV6-3 steel pipeline is positive and equals to +12°C.

For the 10CrMo9-10 steel secondary steam pipeline after 240 000 h service the requirement for tensile strength at room temperature R_m , yield point at room temperature $R_{e\ min}$ and min. yield point R_e^t at a temperature similar to the operating one is met. Also, the brittle fracture appearance transition temperature for both the parent material and the circumferential welded joint is negative.

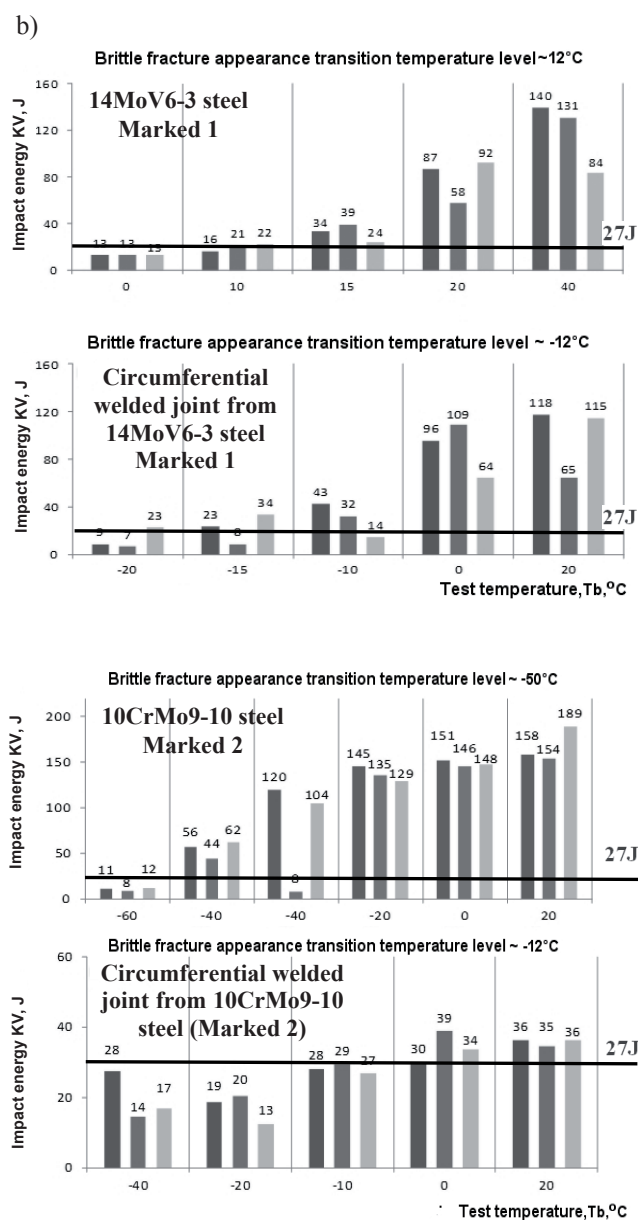
Fig. 2. Results of mechanical testing of the material of tested specimens with homogeneous circumferential welded joint after 240 000 h service under creep conditions: b) impact energy at different test temperature levels for 14MoV6-3 steel primary steam pipeline (marked 1) and 10CrMo9-10 steel secondary steam pipeline (marked 2)

The above-mentioned information is necessary to take a decision in the event when pressure test is required. This test must then take into consideration the level of these properties in the selection of water pressure test parameters. This can only be the leak proof test of the pipeline, not the strength test. As the brittle fracture appearance transition temperature of parent material of the 14MoV6-3 (13HMF) steel primary steam pipeline after 240 000 h service is positive, the required boiler start-up and shutdown conditions should be followed absolutely.

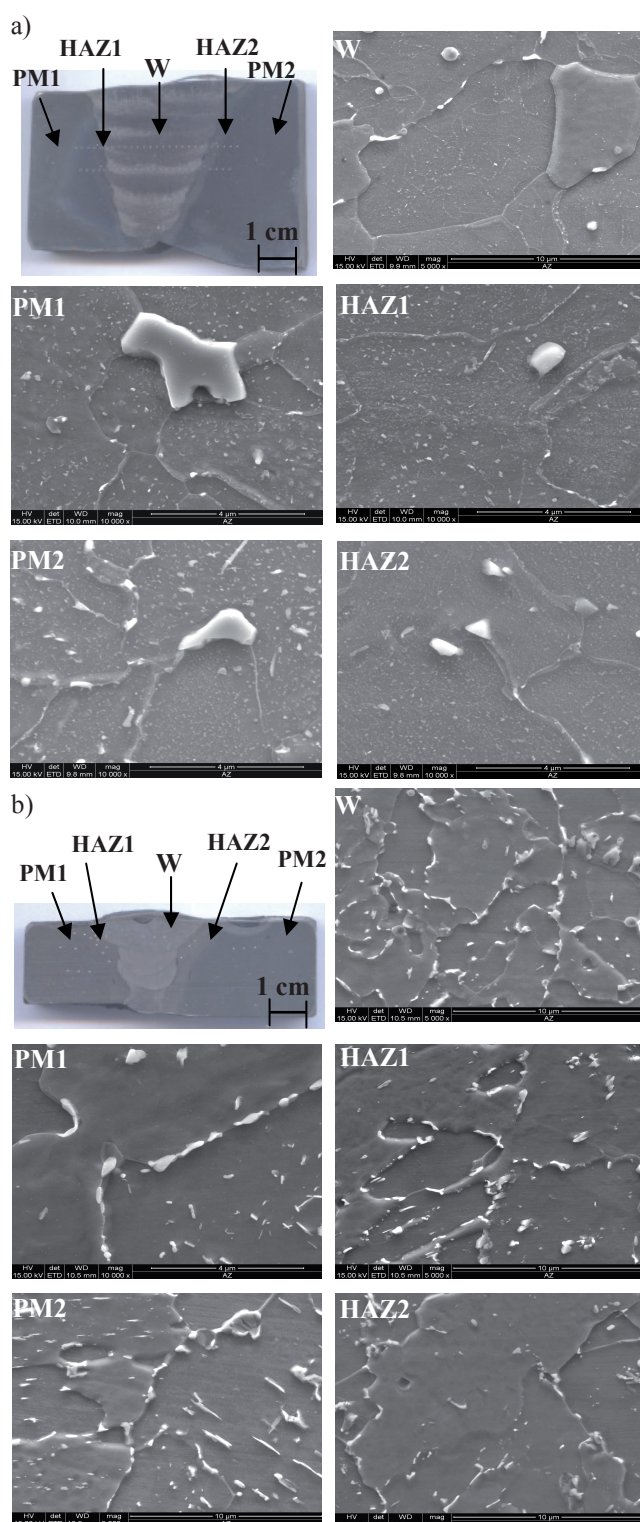
Fig. 3. Comparison of microstructure of the elements of welded joint: MR, HAZ and SP of: a) 14MoV63 primary steam pipeline (marked 1); b) 10CrMo9-10 secondary steam pipeline (marked 2); SEM

Material for investigations		Description of microstructure Material condition – exhaustion extent	Hardness HV10
Element: Primary steam pipeline		Ferritic-bainitic structure. Partially coagulated bainitic areas. At the ferrite grain boundaries, there are precipitates of different size, mostly fine. Inside the ferrite grains, there are very fine evenly distributed precipitates.	
Grade: 14MoV6-3 (13HMF)	PM	No discontinuities and micro-cracks are observed in the structure. No initiation of damaging processes is observed. Bainitic areas: class I, precipitates: class a <u>Damaging processes: class O</u>	156
Service time: 240 000 h service		CLASS 1/2, EXHAUSTION EXTENT: approx. 0.3	
	HAZ	Heat-affected zone structure. No discontinuities and micro-cracks are found in the structure.	191
designation ZGP1	W	Structure of weld material in welded joint. No discontinuities and micro-cracks are found in the structure.	189

Element: Secondary steam pipeline		Ferritic-bainitic structure. Partially coagulated bainitic areas. At the ferrite grain boundaries, there are precipitates, some of rather significant size, forming chains in places. Inside the ferrite grains, there are numerous, mostly fine, precipitates.	
Grade: 10CrMo9-10 (10H2M)	PM	No discontinuities and micro-cracks are observed in the structure. No initiation of damaging processes is observed. Bainitic areas: class I, precipitates: class a <u>Damaging processes: class O</u>	149
Service time: 240 000 h service		CLASS 1/2, EXHAUSTION EXTENT: approx. 0.3	
	HAZ	Heat-affected zone structure. No discontinuities and micro-cracks are found in the structure.	172
designation ZGP1	W	Structure of weld material in welded joint. No discontinuities and micro-cracks found in the structure.	201

The obtained results of mechanical testing in combination with the results of structure investigations for the primary and secondary steam pipeline show slight wear-out of the tested material the exhaustion extent t_b/t_r of which was estimated to be approx. 0.3.

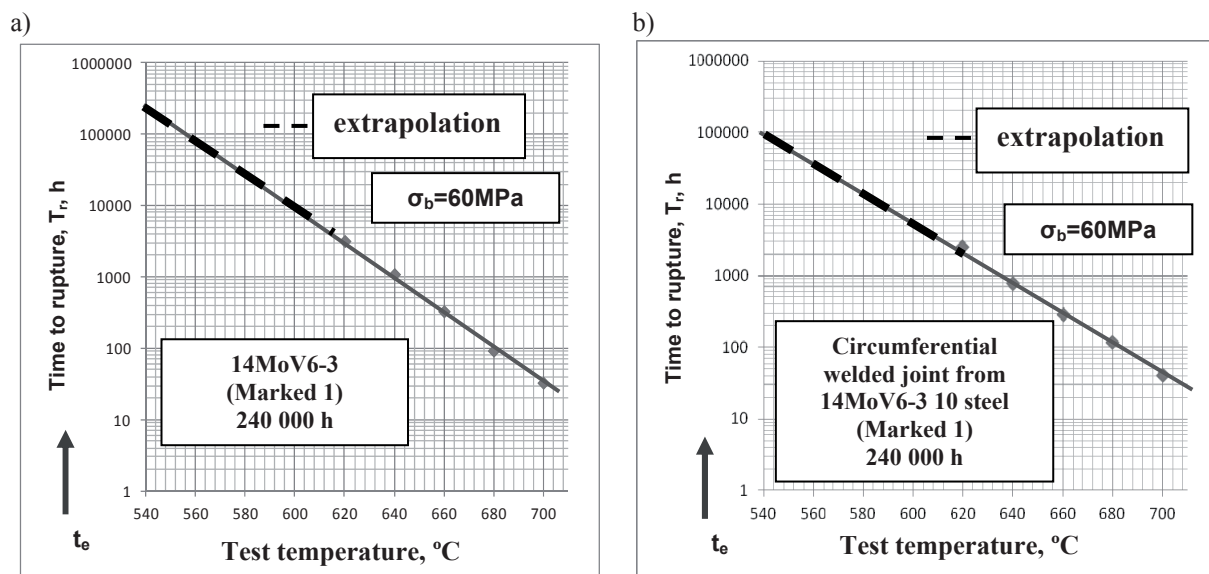
The obtained results of abridged creep tests for the material of pipeline and circumferential welded joint in the tested specimen of 14MoV6-3 steel primary steam pipeline (marked 1) after 240 000 h service under creep conditions conducted at constant stress level $\sigma_b = 60$ MPa, corresponding to the assumed working stress σ_r of further operation, are presented in the form of relationship $t_r = f(T_b)$ at $\sigma_b \approx \sigma_r$ in Fig. 4 and summarised in Table 3, while the

Fig. 4. Results of abridged creep tests of: a) pipeline material; b) circumferential welded joint of the 14MoV6-3 (13HMF) steel primary steam pipeline after 240 000 h service under creep conditions, as relationship $\log t_{r_e} = f(T_b)$ at $\sigma_b = 60$ MPa

The abridged creep tests of circumferential welded joint of the 14MoV6-3 steel primary steam pipeline and the 10CrMo9-10 steel secondary steam pipeline after 240 000 h service carried out at constant test stress, $\sigma_b = \text{const}$, allowed the residual life to be determined and the disposable residual life to be evaluated for the expected operating temperature of 540°C. The residual life t_{re} determined for the material of pipeline and circumferential welded joint of the 14MoV6-3 steel primary steam pipeline after 240 000 h service is 200 thousand hours and 100 thousand hours, respectively, and the estimated residual creep strength t_b is 110 thousand hours and 55 thousand hours, respectively, while the residual life t_{re} determined for the material of pipeline and circumferential welded joint of

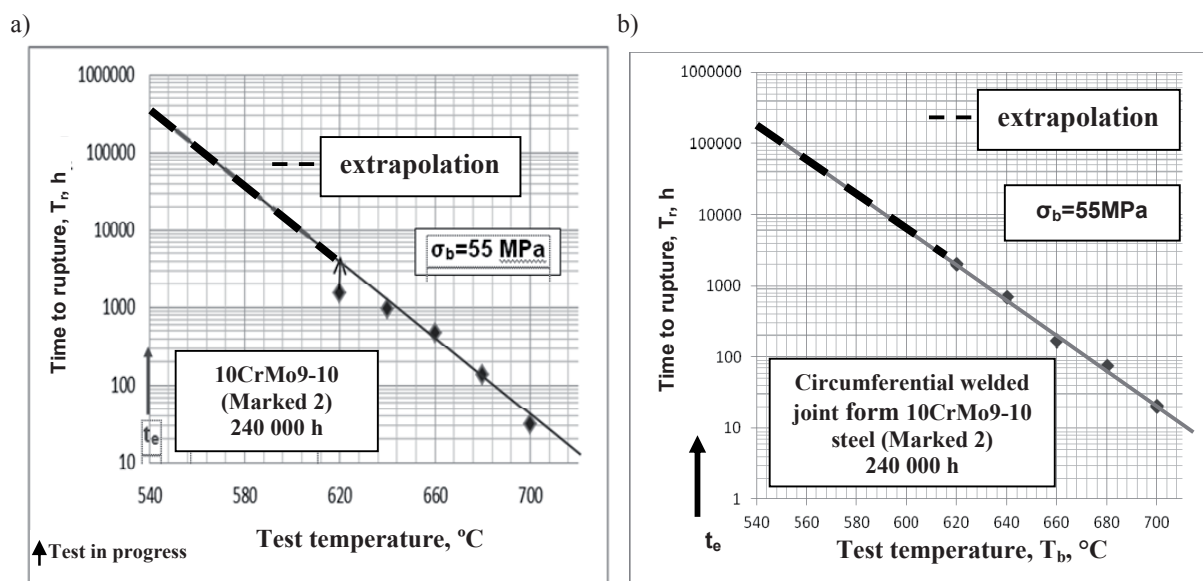
obtained results of abridged creep tests for the material of pipeline and circumferential welded joint in the tested specimen of 10CrMo9-10 steel secondary steam pipeline (marked 2) after 240 000 h service under creep conditions conducted at constant test stress level $\sigma_b = 55$ MPa, corresponding to the assumed working stress σ_r of further operation, are presented in the form of relationship $t_r = f(T_b)$ at $\sigma_b \approx \sigma_r$ in Fig. 5 and summarised in Table 3.

Fig. 5. Results of abridged creep tests of: a) pipeline materials; b) circumferential welded joint of the 10CrMo9-10 (10H2M) secondary steam pipeline after 240 000 h service under creep conditions, as relationship $\log t_{r_e} = f(T_b)$ at $\sigma_b = 55$ MPa

the 10CrMo9-10 steel secondary steam pipeline after 240 000 h service is 300 thousand hours and 200 thousand hours, respectively, and the estimated residual creep strength t_b is 165 thousand hours and 110 thousand hours, respectively.
