Residual life of the (15HM) 13CrMo4-5 steel after 250 000 h service demonstrating internal damages in the form of voids

Purpose: The purpose of the paper was to evaluate the material condition of the (15HM) 13CrMo4-5 steel after 250 000 h service under creep conditions demonstrating internal damages in the form of voids.

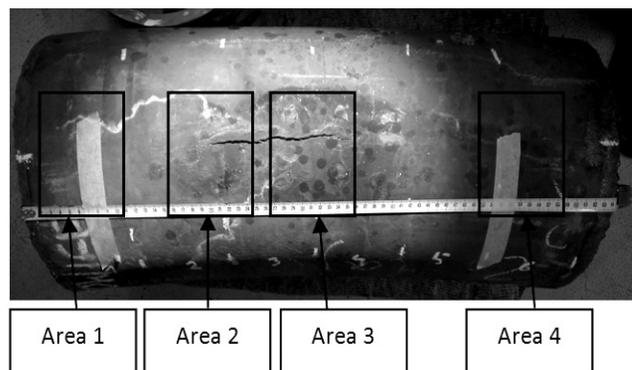
The material for investigations was a specimen of the (15HM) 13CrMo4-5 steel steam pipeline elbow after approx. 250 000 h service under creep conditions with a damage in the form of cracking along the steam pipeline axis. The material for investigations is presented in Fig. 1.

Fig. 1. Material for investigations in the form of the 13CrMo4-5 low-alloy steel steam pipeline specimen with visible damaged area and indicated sampling areas

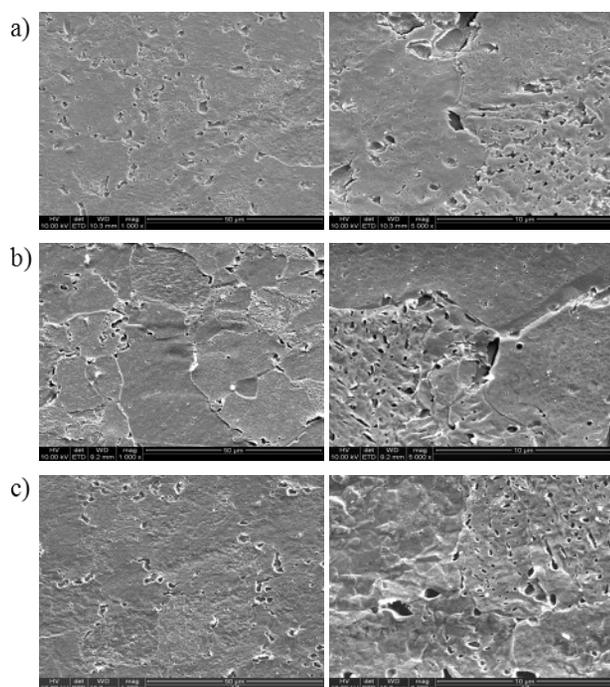
The internal damage processes are local, therefore to reveal the area of their occurrence within the examined pipeline specimen material, the investigations were carried out within the indicated areas of the pipeline material. For each of the examined areas (area 1-4) the evaluation of material condition, including the internal damages, was made in accordance with the Institute for Ferrous Metallurgy's own classification. Based on the microstructure investigations by the matrix replica method, the areas of the pipeline material with creep voids and with no internal damages were distinguished.

Fig. 3. Structure of the steam pipeline specimen material: a) with no internal damages (area 4); b) with internal damages in the form of voids (area 1); c) with internal damages in the form of micro-cracks (area 3) - SEM replica

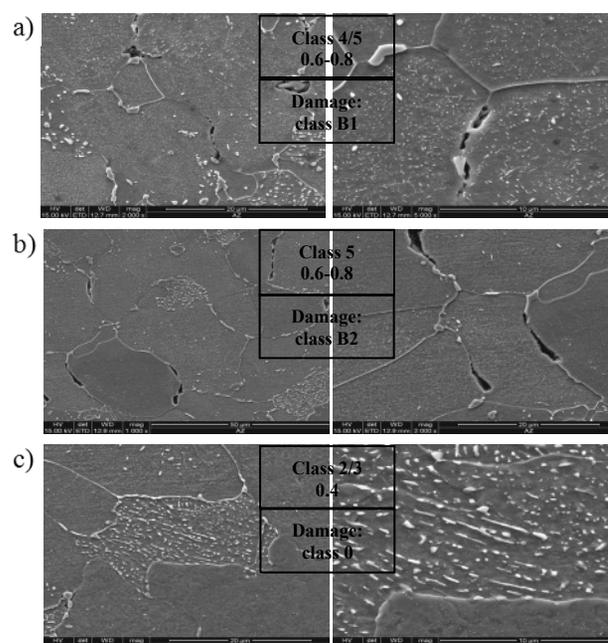
Fig. 4. Microstructure of the steam pipeline specimen material over the element thickness within the area beyond the external damage (area 1): a) external surface; b) middle surface; c) internal surface - SEM microsection

The investigations of microstructure carried out over the steam pipeline element thickness allowed the state of development of carbide precipitation processes and development of internal damages (Figs 4, 5) to be assessed. The nature of stresses in case of pipeline elements causes that higher structure degradation and initiation of internal damage processes should be expected on the external side, which is confirmed by test results. For area beyond the visible internal damage the oriented voids (class B1) were observed on the external side, while on the internal side no internal damages were observed (class O). For area with visible internal damage micro-cracks (class D) were observed on the external side, while on the internal side there were the coalescences of voids (class B2).

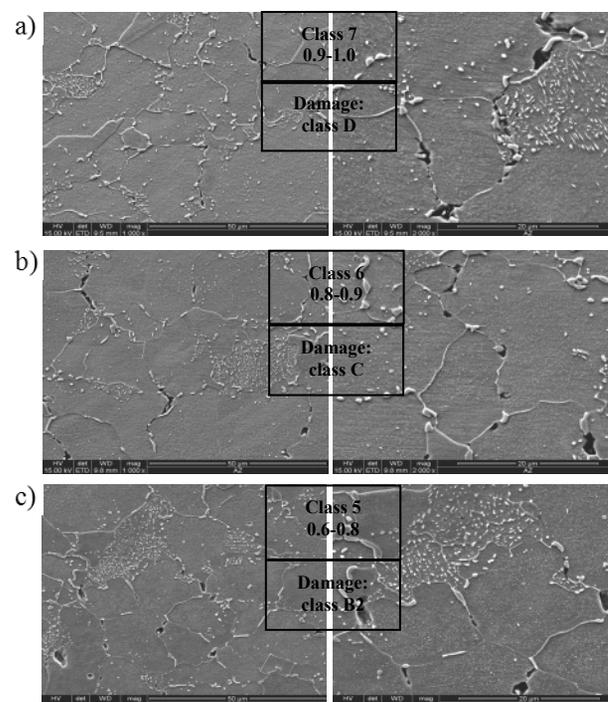
Fig. 5. Microstructure of the steam pipeline specimen material over the element thickness within the area with external damage (area 3): a) external surface; b) middle surface; c) internal surface - SEM microsection

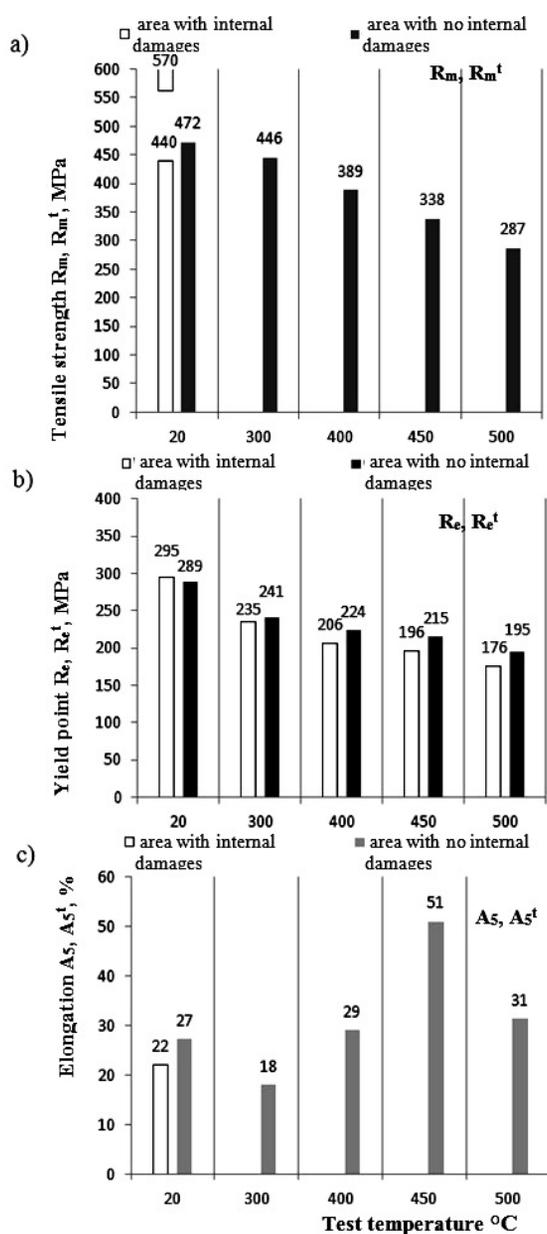
Fig. 6. Relationship between strength properties of the examined 13CrMo4-5 steel steam pipeline specimen material after 250 000 h service from test temperature T_b within the area of internal damages in the material, in particular: a) tensile strength R_m^t , b) yield point R_e^t , c) elongation A_5

The investigations of mechanical properties revealed that tensile strength obtained for the material with damages in the form of creep voids at room temperature is slightly above the minimum level required for material in the as-received condition. At elevated temperature, it is on satisfactory level too. The yield strength values obtained at elevated temperature are slightly above the minimum level required for material in the as-received condition. Only at room temperature, the obtained value is slightly below the minimum one required for material in the as-received condition. In addition, the elongation level in tensile test at room temperature is above the required minimum value for the as-received condition, which is 22%. At test temperature of 300°C, the values of 18% were obtained, while at other temperature levels - the values were well above the requirements for the as-received condition at room temperature. Low elongation value at 300°C and diverse

values at other test temperature levels may be the evidence of non-uniform distribution of creep voids within the examined material after service.

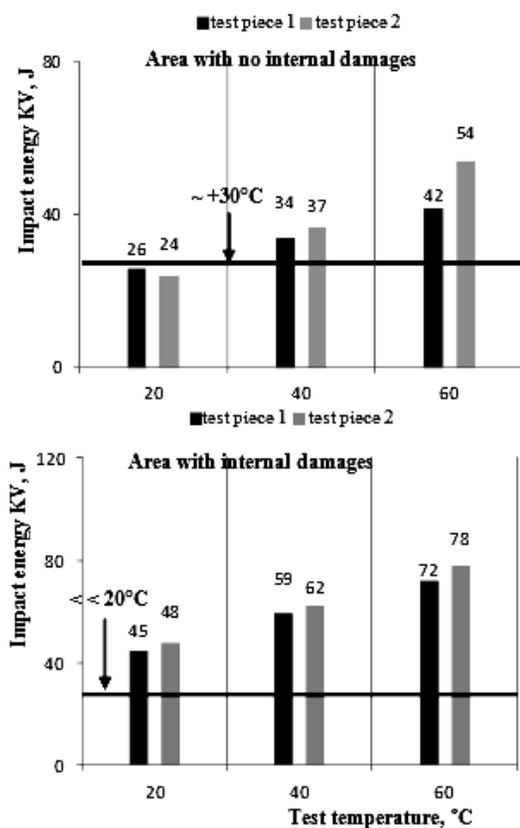
Fig. 7. Test results of impact energy measured on V-notch samples depending on test temperature of the steam pipeline specimen: a) within the area of internal damages; b) within the area with no damages confirmed

In accordance with expectations, the impact energy of the material after service with creep voids is much lower, regardless of the test temperature level, than that obtained for the same material after service without internal damages, characterised by identical state of disintegration of pearlite areas and state of development of carbide precipitation processes. It represents approx. 50% of the values obtained for the material with no creep voids. The significant difference also occurred at the determined brittle fracture appearance transition temperature, although it was obtained on limited number of test pieces and limited number of test temperature levels. The determined brittle fracture appearance transition temperature for the material with no creep voids is negative and much below room temperature, whereas for the material after service with creep voids, this temperature is positive and equals to approx. + 30°C.

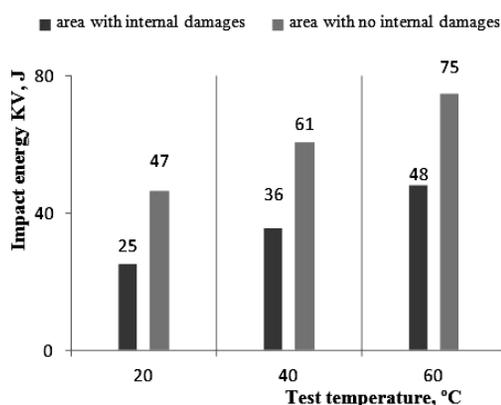
Fig. 8. Comparison of impact energy results for the 13CrMo4-5 steel steam pipeline specimen material tested within the area of internal damages to impact energy results measured within the area with no internal damages confirmed
