Structure of welded joints of 14MoV6-3 and 13CrMo4-5 steel elements after design work time under creep conditions

A. Zieliński*, J. Dobrzański, M. Dziuba-Kaluża

Institute for Ferrous Metallurgy, ul. K. Miarki 12, 44-100 Gliwice, Poland

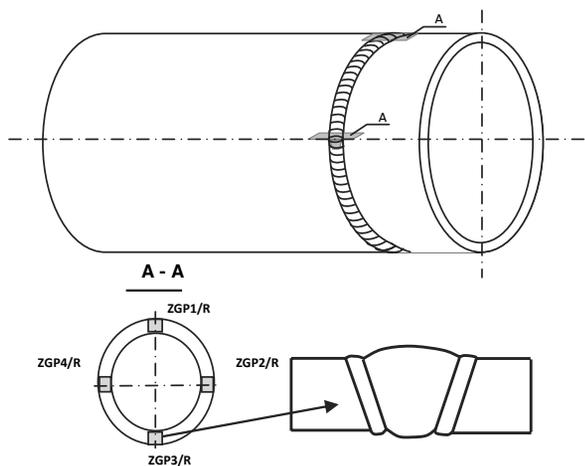
Fig. 5. Designation of area where HV10 hardness measurements and microstructure investigations of the material of 14MoV6-3 steel primary steam pipeline were made

Area of investigation/ HV10	Description of microstructure Material condition – life exhaustion extent	HV10
Parent material 1	Ferritic-bainitic structure. Bainitic areas partially coagulated. At ferrite grain boundaries, few fine precipitations of different size. Precipitations inside ferrite grains, mostly very fine, distributed evenly within the structure. No discontinuities and micro-cracks observed in the structure.	159
Parent material 2	Bainitic areas: class I, precipitations: class a <u>Destruction processes: class O</u> CLASS 1/2, LIFE EXHAUSTION EXTENT: approx. 0.3	153
HAZ 1	Heat-affected zone structure. No discontinuities and micro-cracks found in the structure.	167
WELD	Structure of welded joint weld material. No discontinuities and micro-cracks found in the structure.	218
HAZ 2	Heat-affected zone structure. No discontinuities and micro-cracks found in the structure.	172

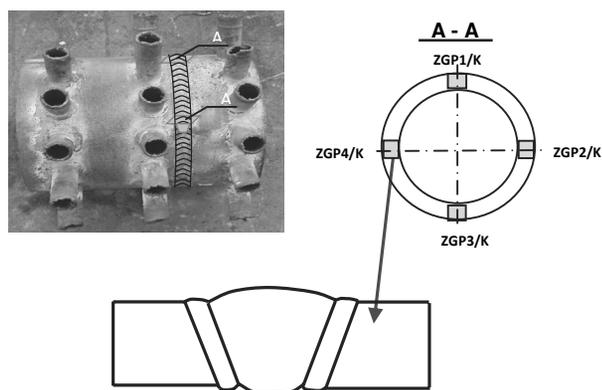
Fig. 6. Designation of area where HV10 hardness measurements and microstructure investigations of the material of 13CrMo4-5 steel inlet header were made

Area of investigation/ HV10	Description of microstructure Material condition – life exhaustion extent	HV10
Parent material 1	Ferritic-pearlitic-bainitic structure. pearlite/bainite areas partially coagulated. At ferrite grain boundaries, numerous precipitations forming chains in places. inside ferrite grains, single fine precipitations.	155
Parent material 2	Pearlite/bainite areas: class I, precipitations: class a <u>Destruction processes: class O</u> CLASS 1/2, LIFE EXHAUSTION EXTENT: approx. 0.3	157
HAZ 1	Heat-affected zone structure. No discontinuities and micro-cracks found in the structure.	166
WELD	Structure of welded joint weld material. No discontinuities and micro-cracks found in the structure.	197
HAZ 2	Heat-affected zone structure. No discontinuities and micro-cracks found in the structure.	197

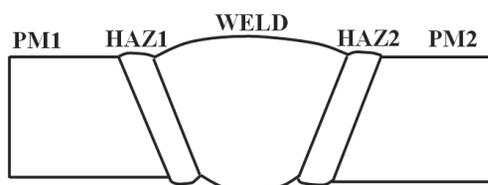
Fig. 7. Areas where microstructure photos of tested welded joints were taken. Symbols: PM - parent material, HAZ - heat-affected zone, W - weld

Within the examined structure of the materials of elements of 14MoV6-3 steel primary steam pipeline circumferential welded joint and 13CrMo4-5 steel II° secondary steam superheater header after service under creep conditions, neither discontinuities and micro-cracks nor initiation of processes of internal damages as a result of creeping were observed.
