Residual life of the (15HM) 13CrMo4-5 steel after 250 000 h service demonstrating internal damages in the form of voids

Purpose: The purpose of the paper was to evaluate the material condition of the (15HM) 13CrMo4-5 steel after 250 000 h service under creep conditions demonstrating internal damages in the form of voids.

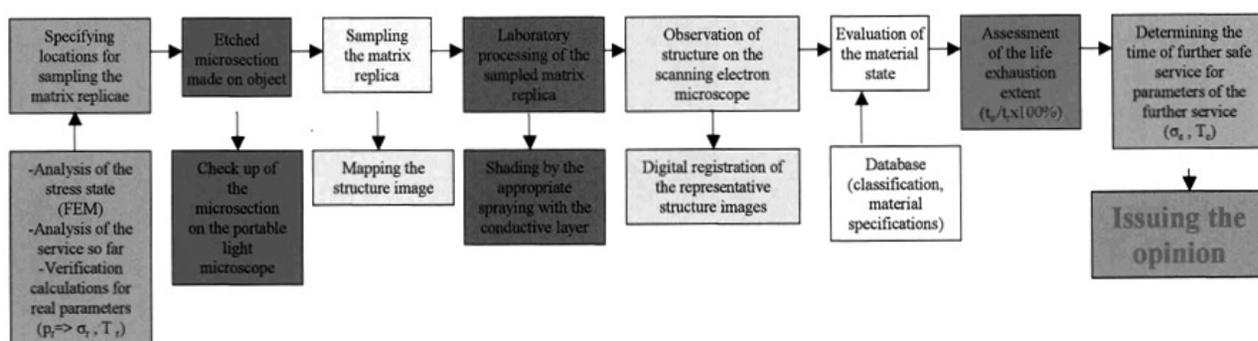
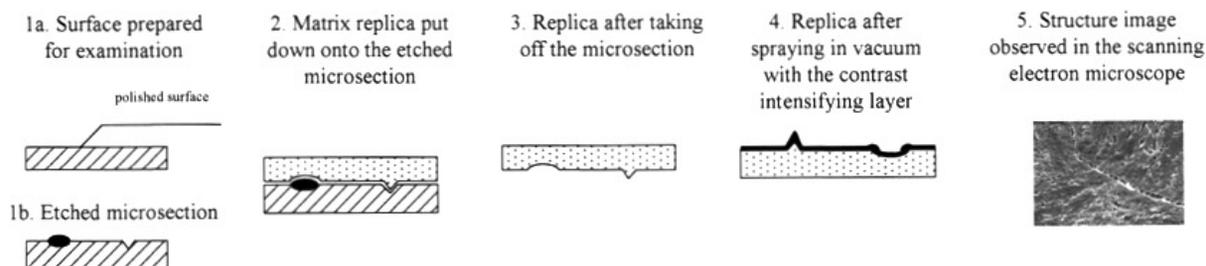
Fig. 2. Method for evaluation and the principle of image mapping by matrix replica

EVALUATION OF THE ELEMENT MATERIAL STATE BASING ON STRUCTURE IMAGE (S_1 – DECAY OF MAIN STRUCTURE PHASES, ω – DEVELOPMENT OF INTERNAL DAMAGES)

THE PRINCIPLE OF IMAGE MAPPING USING MATRIX REPLICA
